Sunnyside Cogeneration Associates

RE: Second Quarter 2007 Inspection Report
Star Point Refuse Pile C/007/042

IMPOUNDMENT INSPECTION AND CERTIFIED REPORT

Sediment Pond 005

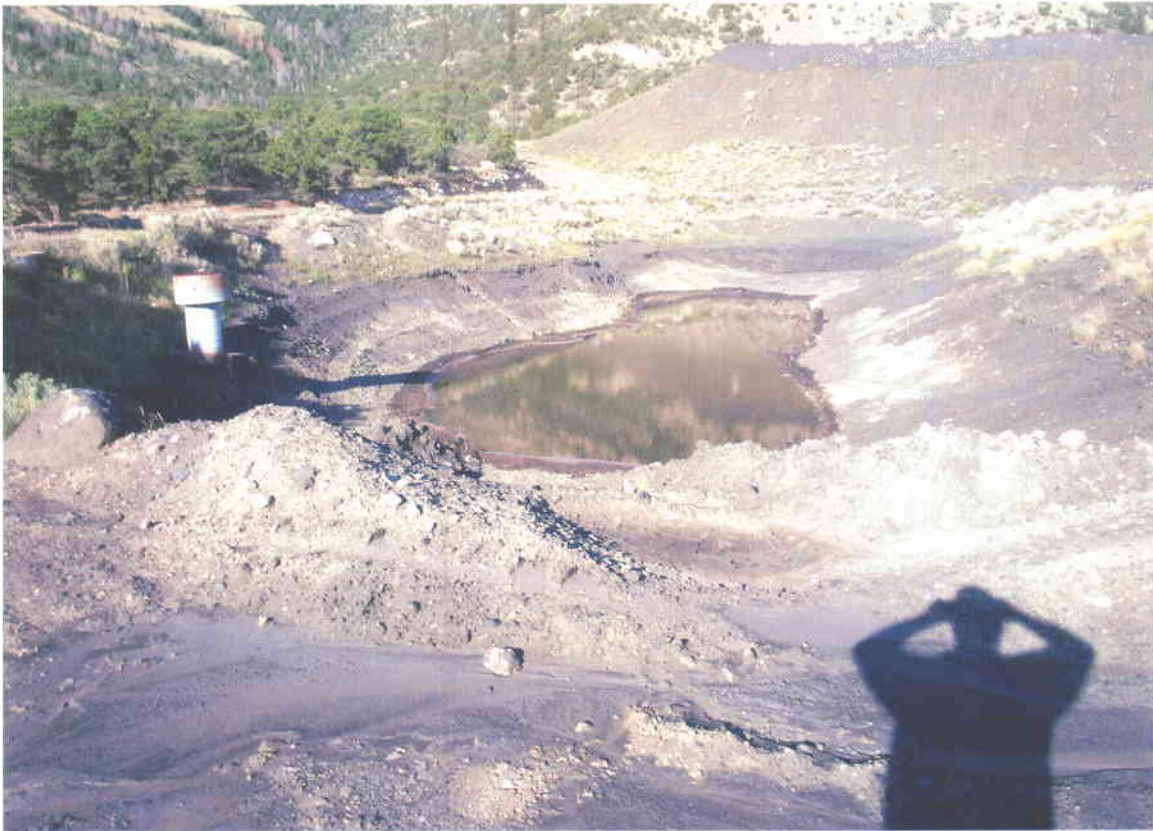
Sediment Pond #005 (looking westerly)

Pond had some water in it but was not discharging. No samples were taken
Sediment had recently been cleaned. Pond did not require decanting.
Embankment conditions were good. Vegetation on out slopes was adequate.
Inlet / Outlet conditions were good. No structural or hazardous conditions were observed.

No recent changes in the geometry of the structure have been observed beyond sediment cleaning

Depth of impounded water was minimal

Sediment level was good.

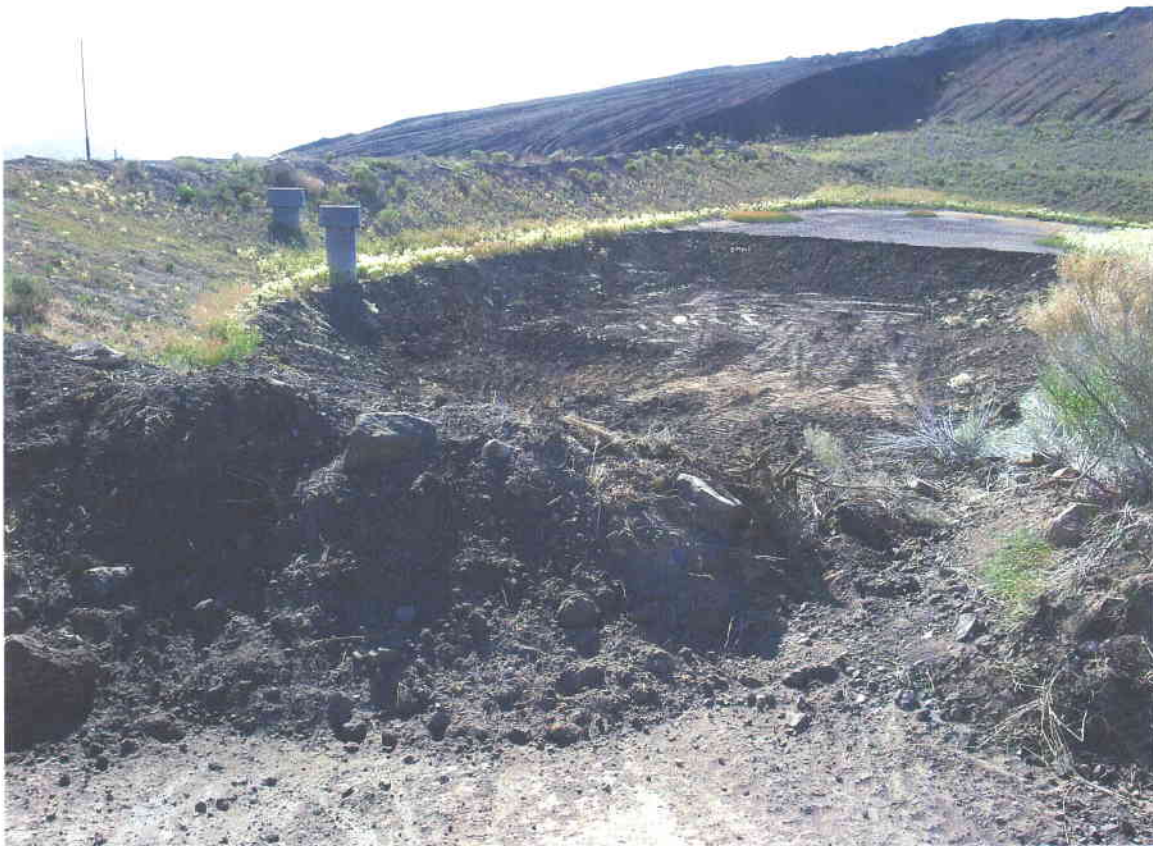
Sediment Pond #009 (looking easterly)

Pond had no water in it. No samples were taken. Pond did not require decanting.
Sediment had recently been cleaned across much of the pond.
Embankment conditions were good. Vegetation on out slopes was adequate.
Inlet / Outlet conditions were good. No structural or hazardous conditions were observed.

No recent changes in the geometry of the structure have been observed beyond sediment cleaning

Depth of impounded water was minimal

Sediment level was good.

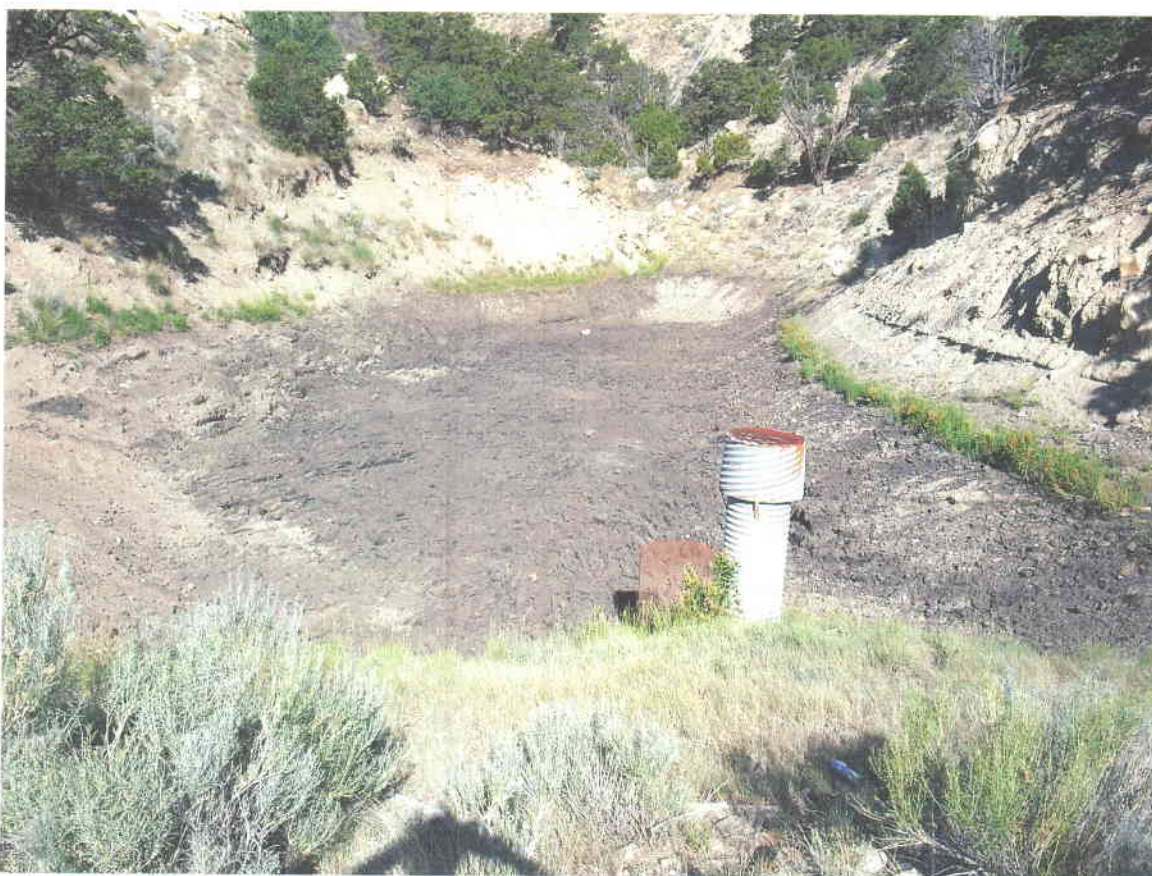
Sediment Pond #006 (looking westerly)

Pond had no water in it. No samples were taken
Sediment had recently been cleaned. Pond did not require decanting.
Embankment conditions were good. Vegetation on out slopes was adequate.
Inlet / Outlet conditions were good. No structural or hazardous conditions were observed.

No recent changes in the geometry of the structure have been observed beyond sediment cleaning

Depth of impounded water was minimal

Sediment level was good.
